# HomeOwner Services, Inc.

## Sample Inspection Report

1241 Wayne Street, Anytown , IL 60004

1/28/2008

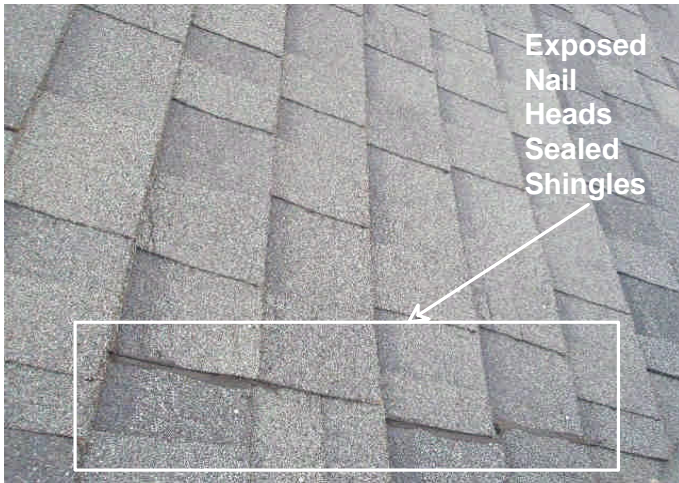
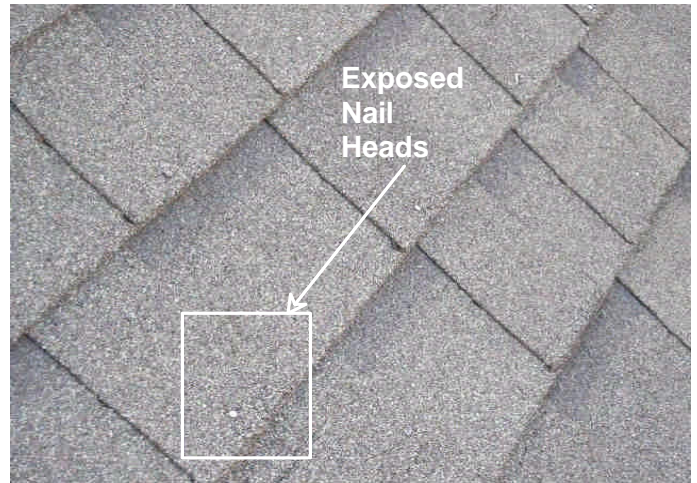
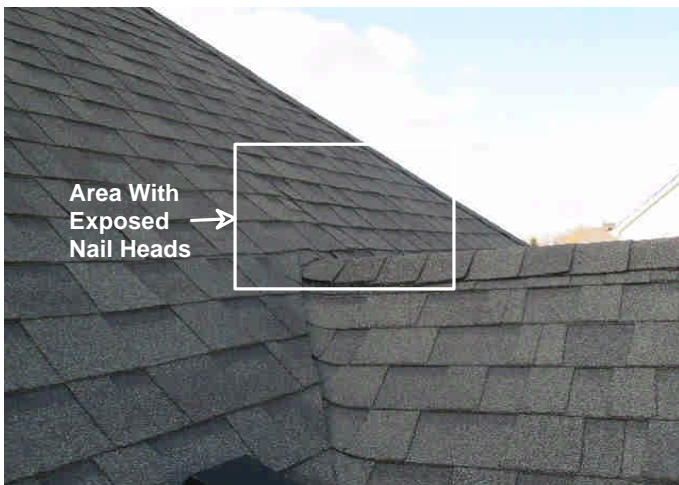
- There are exposed nails heads on some of the shingles on the east side. This may allow water to enter. The nail heads should be sealed with a caulk of the proper type by a licensed roofing contractor. See Article 3C.29 for more information.

Figure Set - 1 Exposed nails heads

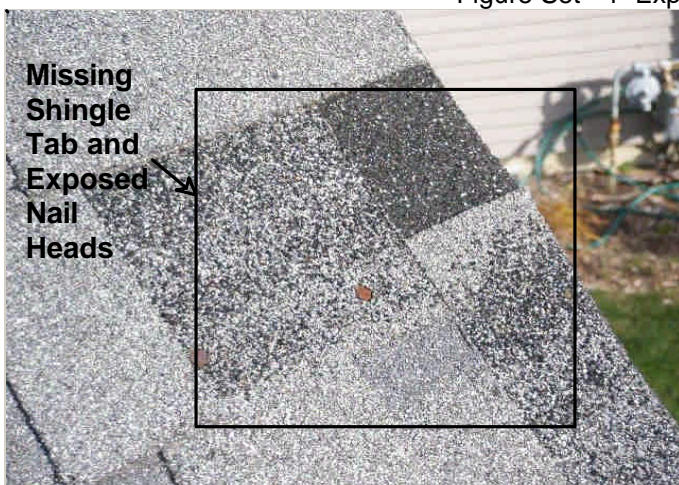
- There is a missing shingle tab on the roof above the 2nd floor east elevation. The lack of shingles could lead to further and more costly damage. Missing shingles should be replaced. Recommend further evaluation and repair by a licensed roofing contractor. See Article 3C.01 for more information.

Figure Set - 2 Missing asphalt shingle tab

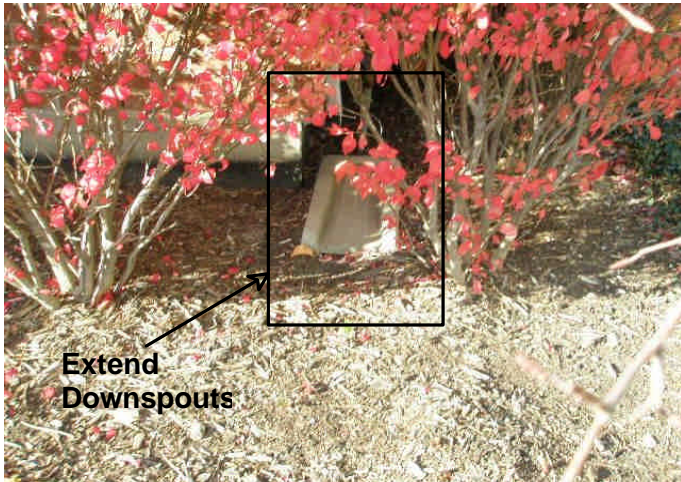
- The downspouts on the southeast and southwest corners of the home empty close to the building foundation. This can promote water intrusion into the structure and could cause settlement of the structure itself. The downspouts must be extended to at least three to six feet from the building, or to a distance equal to the depth of the footings at that location. See Articles 2C.15 and 3C.06 for more information.

Figure Set - 3 Extend downspouts

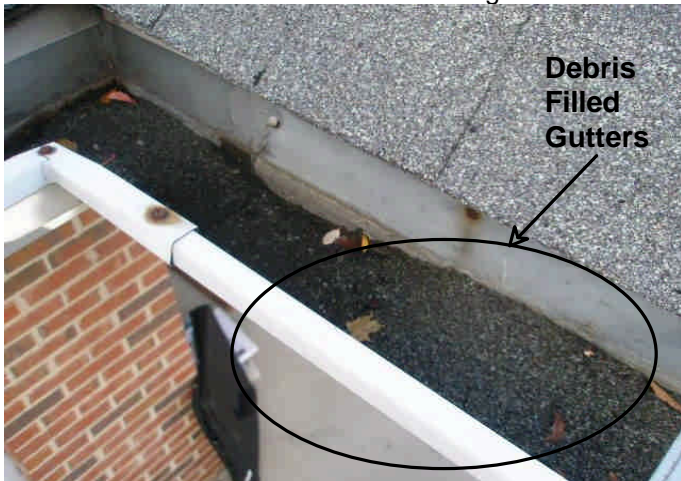
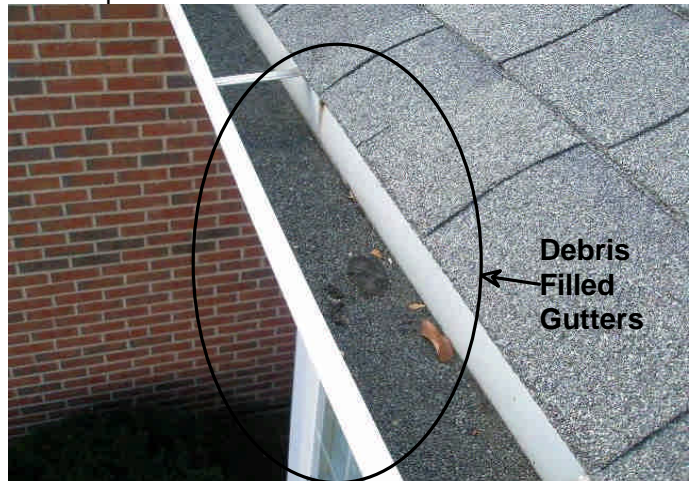
- The gutters above the front porch are clogged with debris. This can cause them to overflow and allow roof runoff to fall close to the building. The gutters should be cleaned function properly. See Article 3C.06 for more information.

Figure Set - 4 Clogged gutters

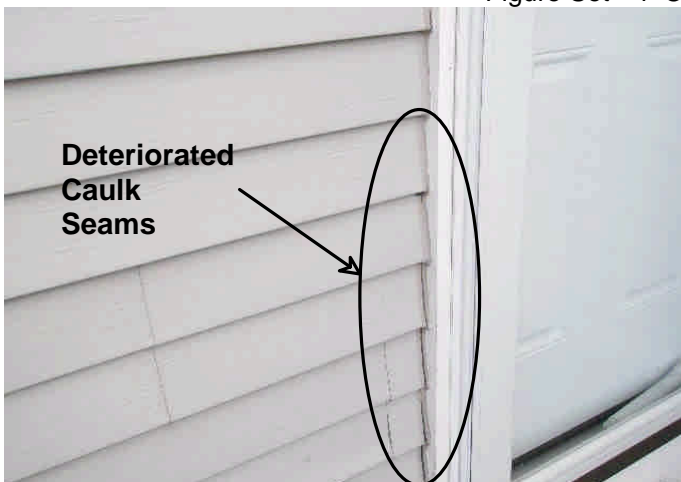
- Some of the exterior wall surface is metal siding without a "J-channel". Siding joints without the "J" channel must always be caulked to prevent water intrusion. There are several joints around door and window frames that have deteriorating caulk. Recommend all deteriorated joints be repaired by a qualified contractor. All See Articles 2A.00 and 2A.02 for more information.

Figure Set - 5 Metal siding without a J-channel

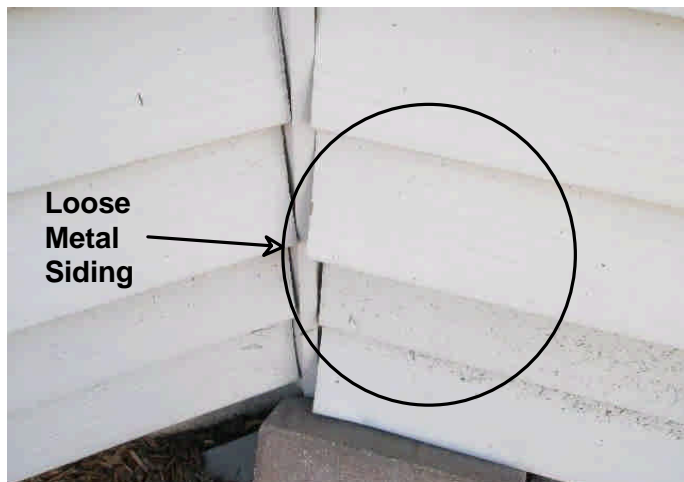
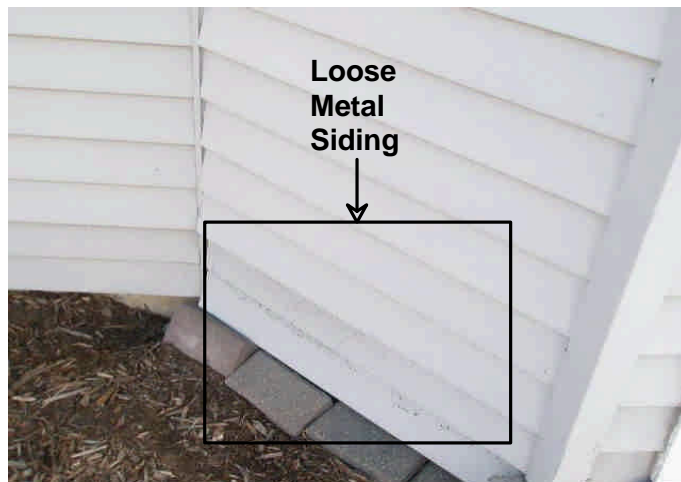
- There is some loose siding on both sides of the back door to the patio. Recommend this siding be repaired by a qualified contractor.

Figure Set - 6 Loose metal siding

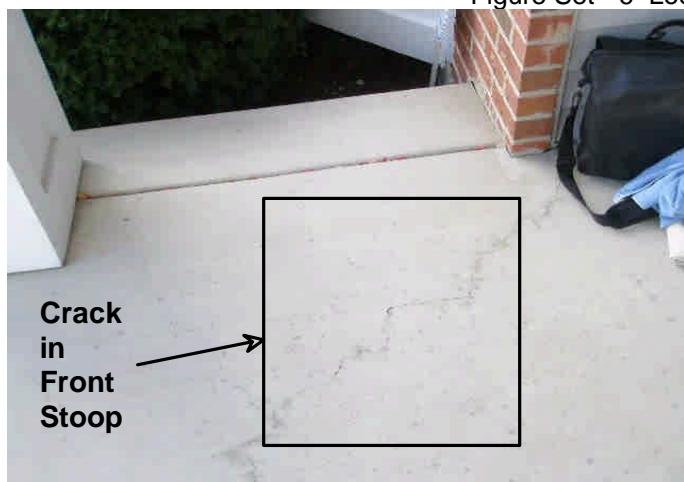
- There are shrinkage cracks in the concrete front porch stoop. You should monitor for changes, future repairs may be necessary if cracks expand. See article 1C.24 for additional information.

Figure Set - 7 Shrinkage cracks in concrete stoop

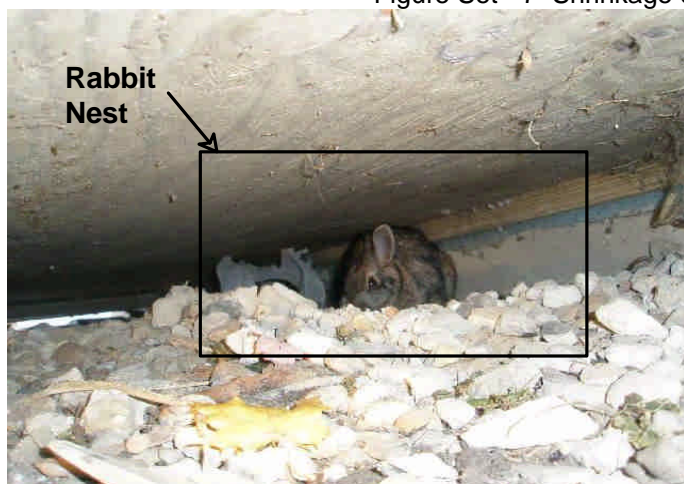
- There is a rabbit nesting under the cantilevered bay for the back door. You should seal access points to prevent further nesting.

Figure Set - 8 Nest under back door bay

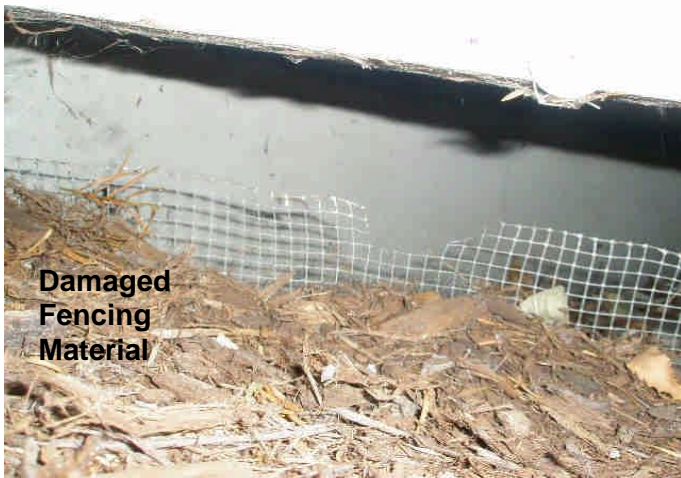
- Small pests are likely to be nesting under the cantilevered front bay window. The screening material has been damaged and should be replaced.

Figure Set - 9 Nest under cantilevered bay window

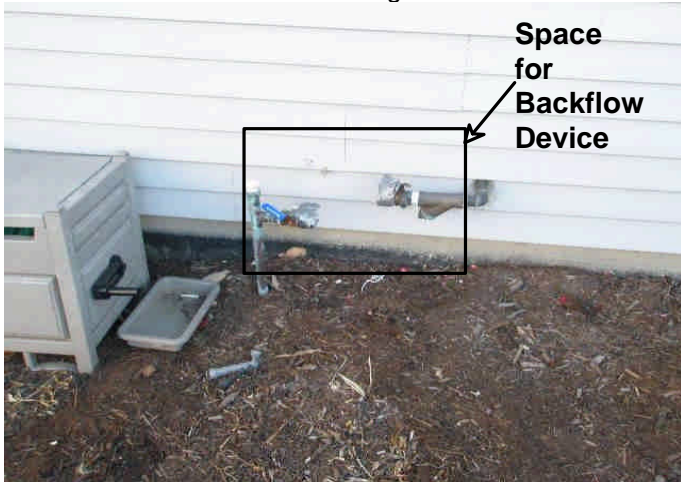
- There is a lawn sprinkling system installed on the property. Testing sprinkler systems is beyond the scope of this inspection. You should have a qualified specialist examine this system. The sprinkler backflow device was removed and placed in the basement by the main water shutoff for the winter, you will need to have this device reinstalled in the spring by a specialists. See Article 4A.14 for more information.

Figure Set - 10 Lawn sprinkler not inspected

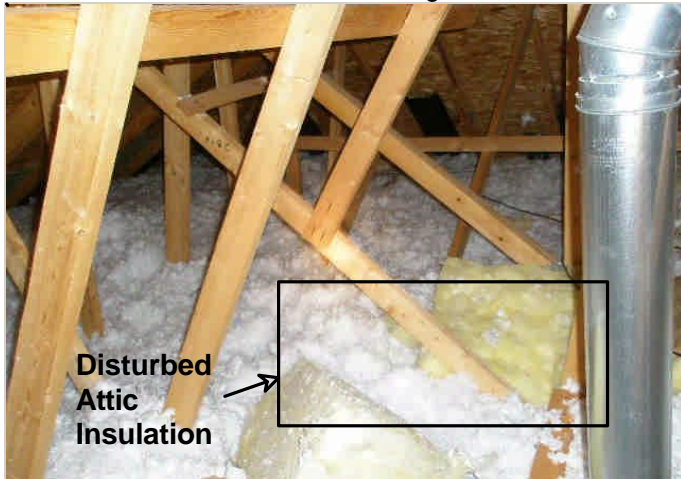
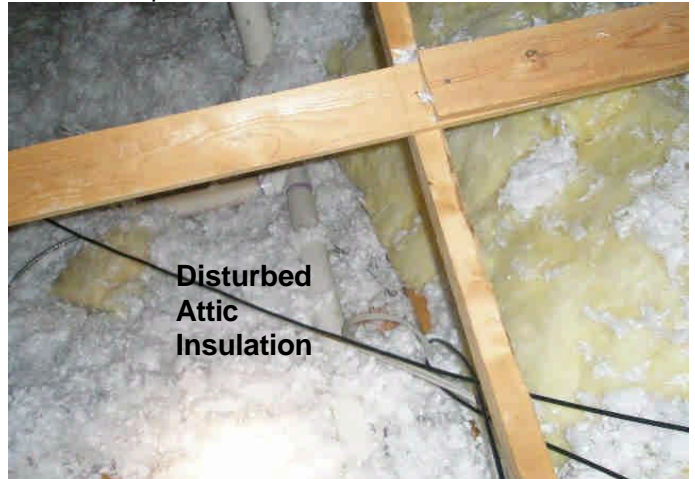
- The attic insulation was disturbed in several areas by contractors installing cables. You should repair any disturbed areas and add additional insulation to ensure adequate energy efficiency.

Figure Set - 11 Insulation disturbed

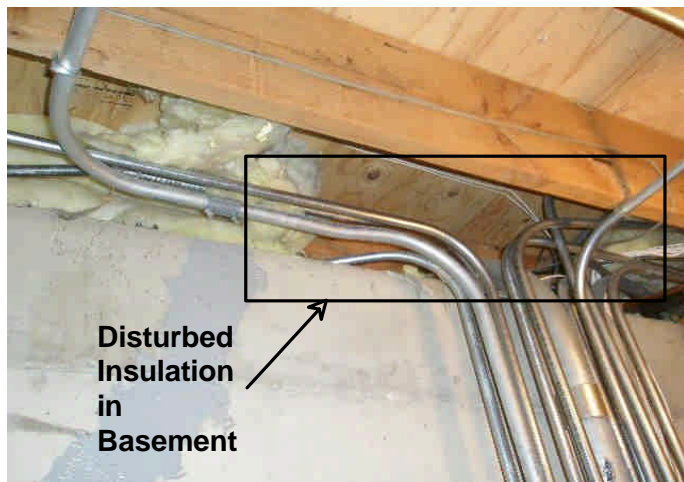
- Some of the insulation at the rim joist above the electrical panel has been disturbed. Recommend repair by a qualified contractor.

Figure Set - 12 Loose or fallen

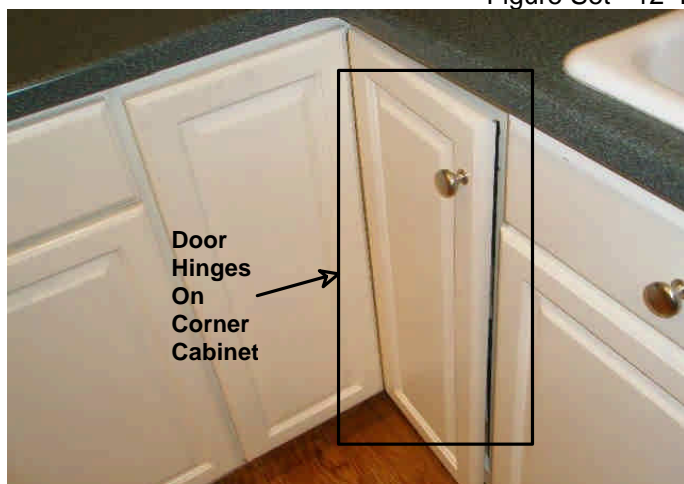
- The north corner base cabinet door will not close and latch properly. This is most likely caused by loose or maladjusted hinges, recommend repair by a qualified contractor. See Article 8C.02 for more information.

Figure Set - 13 Door hinges loose

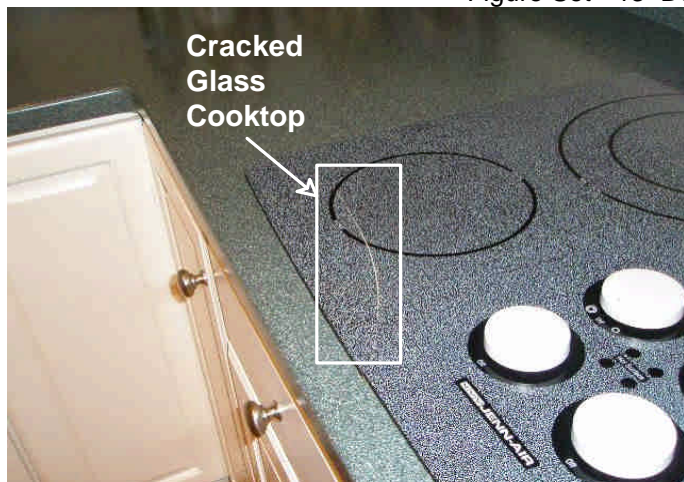
- The glass cooktop is cracked and should be replaced. You should check with a qualified appliance dealer for replacement costs. See 8C.13 for more information.

Figure Set - 14 Cooktop should be replaced
